FPSS.ID.: FPSS-00140  
Inst.ID.: SRON-G/FPU/TN/2000-003  
Issue: 1  
Date: 06OCT2000  
Category: 3

## FPU Failure Mode Effects and Criticality Analysis

Prepared by: K.J. Wildeman

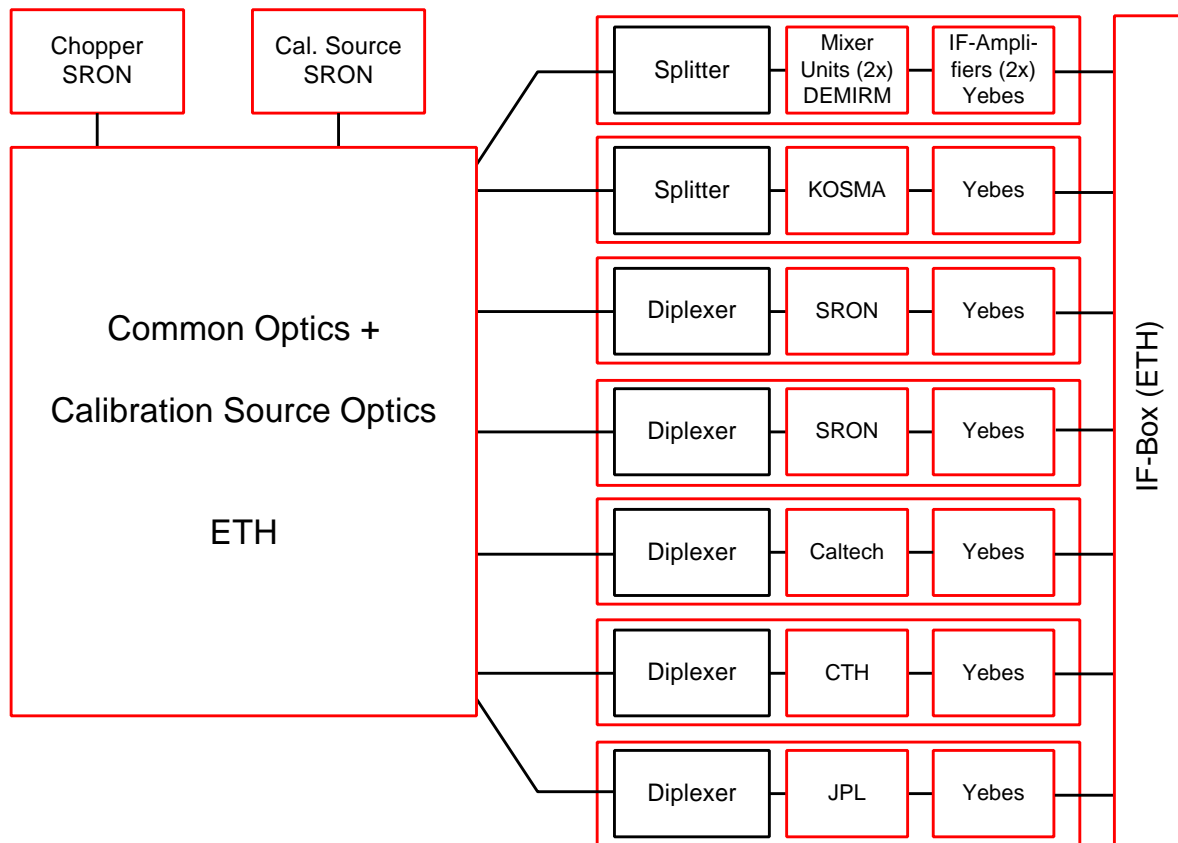
A sub-unit break down is shown in Figure 1. Each Mixer Assembly, containing two mixers for each polarisation, will cover a single frequency band. All bands measure both polarisations of the astronomical signal simultaneously for optimum sensitivity and redundancy.

Figure 1 Sub-units of the FPU. The sub-units are indicated by a red box.

This FMECA has been performed on a sub-unit functional level. Lower level of investigations shall be carried out by the sub-unit suppliers in those cases where the results of this FMECA indicate weak areas. The sub-units of the FPU are shown in Figure 1.
